# Scenario #4: Nature-Like Fish Ladder

# Scenario #2: New Denil Fish Ladder

# Scenario #5: Dam Removal

# Scenario #3: Bypass Channel

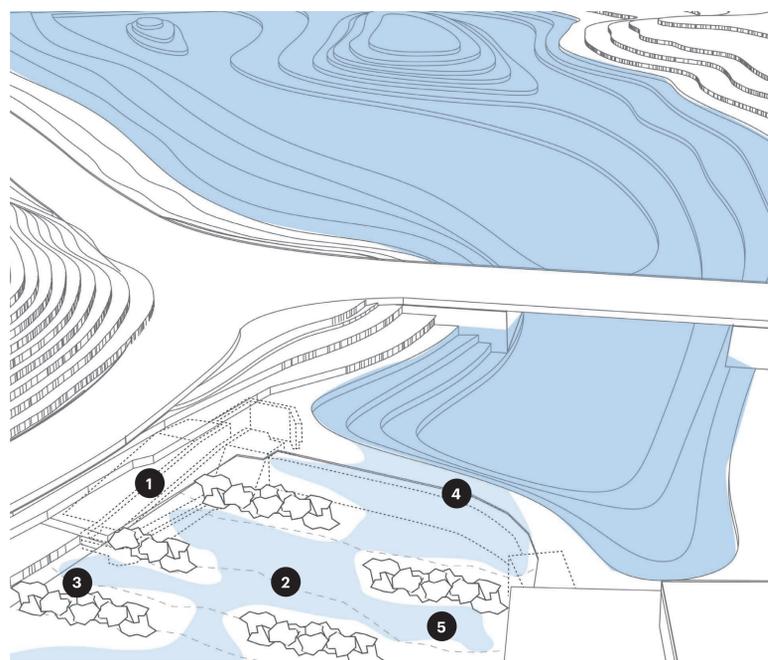
## Operations

- 1 Removed Fish Ladder
- 2 Filled Grade
- 3 Rocky Material
- 4 Covered Dam
- 5 Rest Pools

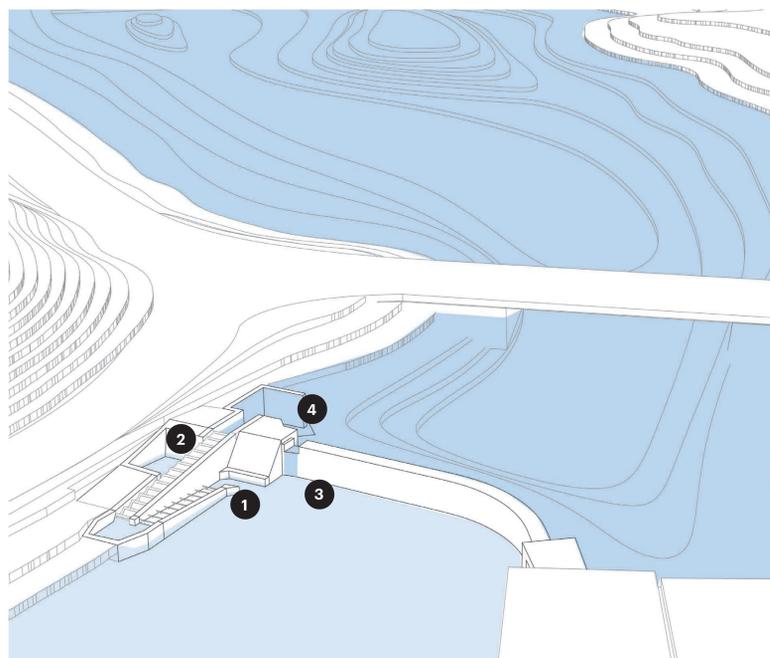
## Operations

- 1 New Denil Fish Ladder Entrance
- 2 Added Resting Pools
- 3 Notch in Weir Crest
- 4 New Denil Fish Ladder Exit

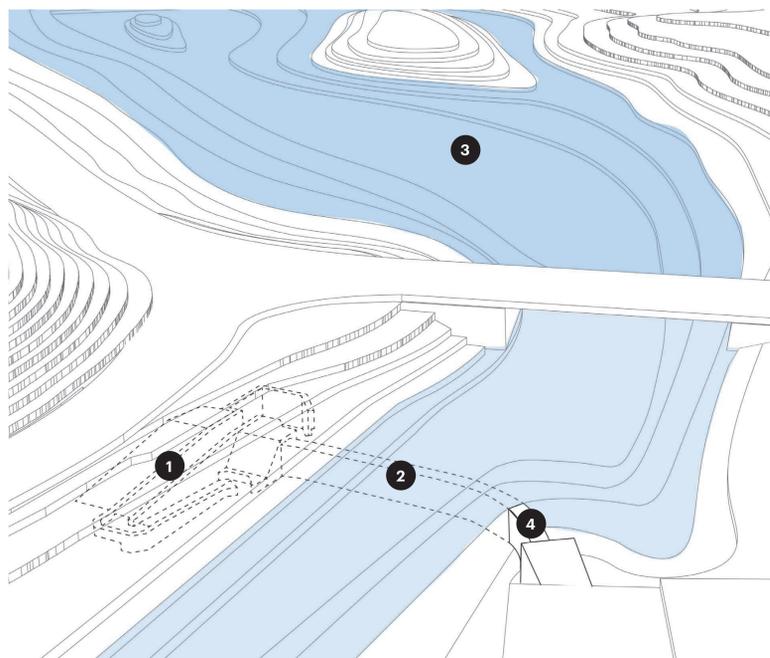
## Operations

- 1 Removed Fish Ladder
- 2 Removed Dam
- 3 Lower water level
- 4 Historic Trace of Dam

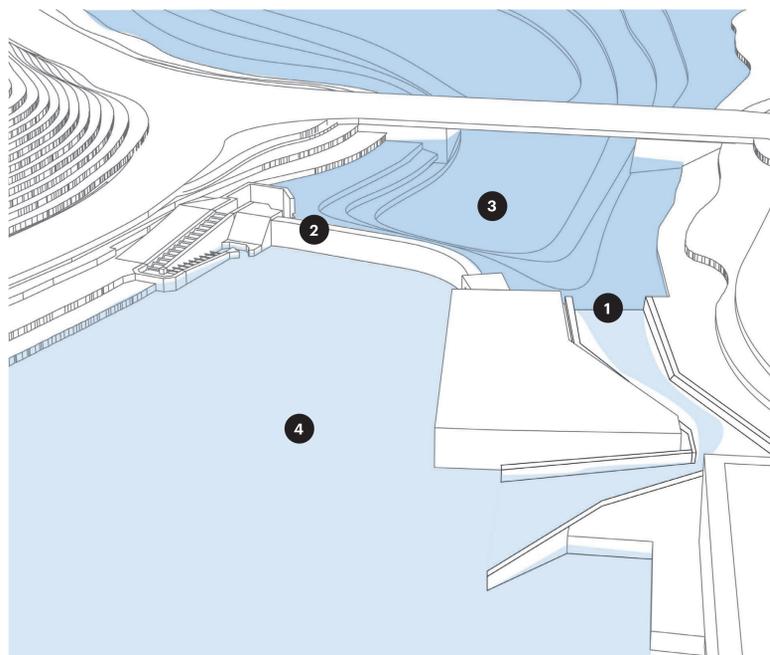
## Operations

- 1 Bypass Channel
- 2 Existing Dam
- 3 Upstream
- 4 Downstream

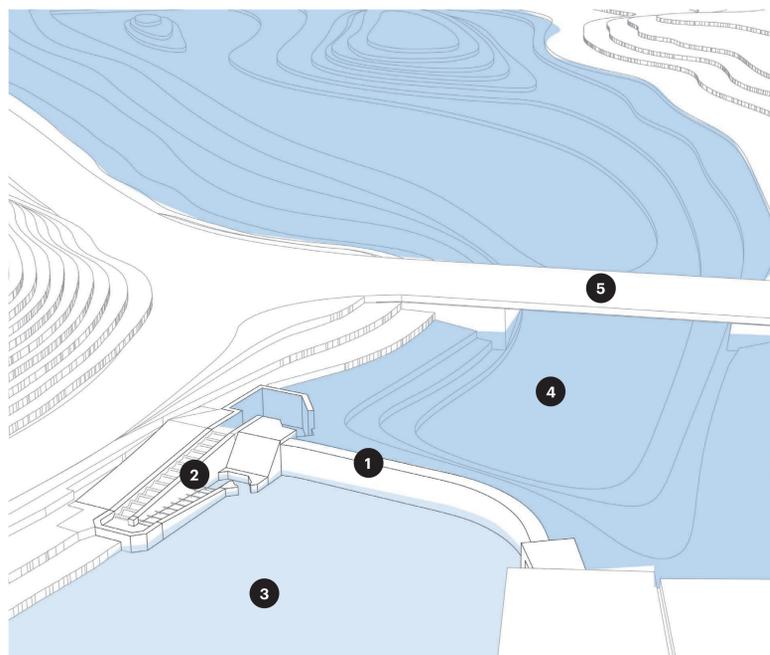
## Operations

- 1 Existing Dam
- 2 Existing Denil Fish Ladder
- 3 Downstream
- 4 Upstream
- 5 Potter Hill Bridge
